## REPORT OF THE COURT OF INQUIRY

1. (U) On 12-13 October 2017, D Squadron of 1 NZSAS Regiment were conducting a regular Maritime Counter Terrorism (MCT) exercise with the Motor Vessel (MV) Olivia Maersk. During the conduct of this activity, an accident occurred that resulted in the death of M995290 SGT W.R. Taylor, RNZIR.

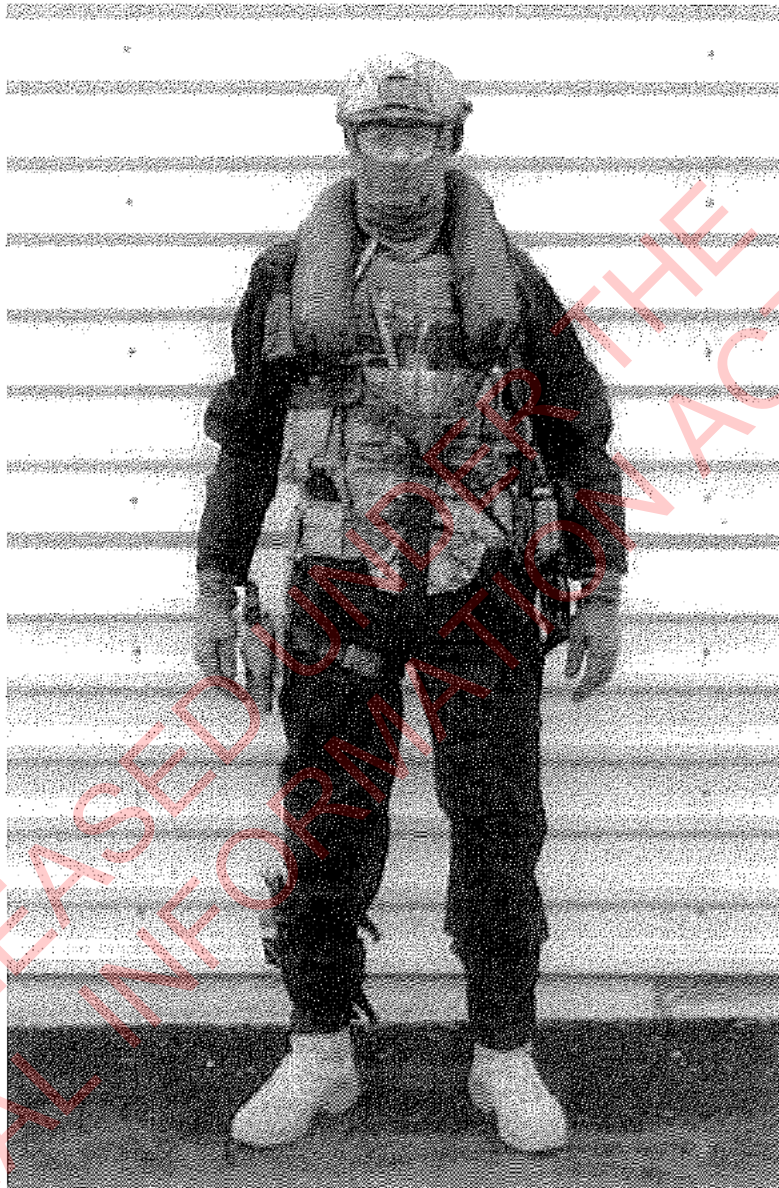
(R) Fig 10 Representative Configuration of Equipment worn by SGT Taylor<sup>450</sup>

152. (R) The Court finds that SGT Taylor was wearing standard assault equipment with some minor personal additions:<sup>444</sup>
- a. Bump Helmet serial No 07616010;
  - b. s. 6(a)
  - c. Helmet mounted strobe light;
  - d. FRIS Suit;<sup>445</sup>
  - e. Boots;
  - f. Body Armour s. 6(a)
  - g. Weapon Sling;
  - h. HK MP5 s. 6(a) Machine Gun) Configured for SIMFIRE;
  - i. Pistol belt and holster;
  - j. Glock SIMFIRE Pistol;
  - k. s. 6(a) HK MP5 Magazine with SIMFIRE ammunition;
  - l. s. 6(a) 5.56 Magazine with s. 6(a) SIMFIRE ammunition;

153. (U) Fig 10 is representative of the configuration SGT Taylor was wearing.
